NASA Contractor Report 181780

Manufacturing Development of Pultruded Composite Panels

L. E. "Roy" Meade

LOCKHEED AERONAUTICAL SYSTEMS COMPANY
BURBANK, CALIFORNIA 91520

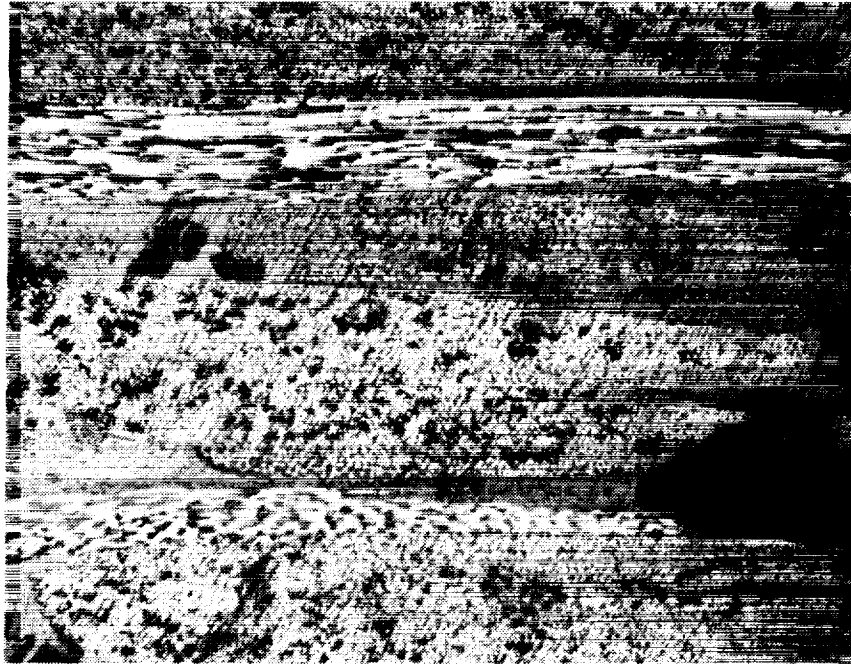
Figure 7. Micrograph of pultruded plate

The cured plate was sent to Lockheed for examination. Ultrasonic inspection indicated a highly porous part. This result was confirmed by photomicrographs of a typical section of the plate as shown in Figure 7. The causes of the porosity were deemed due to the unfilled die problem and improper wet-out of the fabric in the dip tank. These problems had to be

resolved before another plate was pulled. Fabric was ordered woven to a 12-inch width with a leno edge (two twisted glass warp yarns) to hold the warp yarns in place. A larger dip tank was needed plus means to heat the resin to reduce its viscosity to ensure thorough wetting of the fabric.

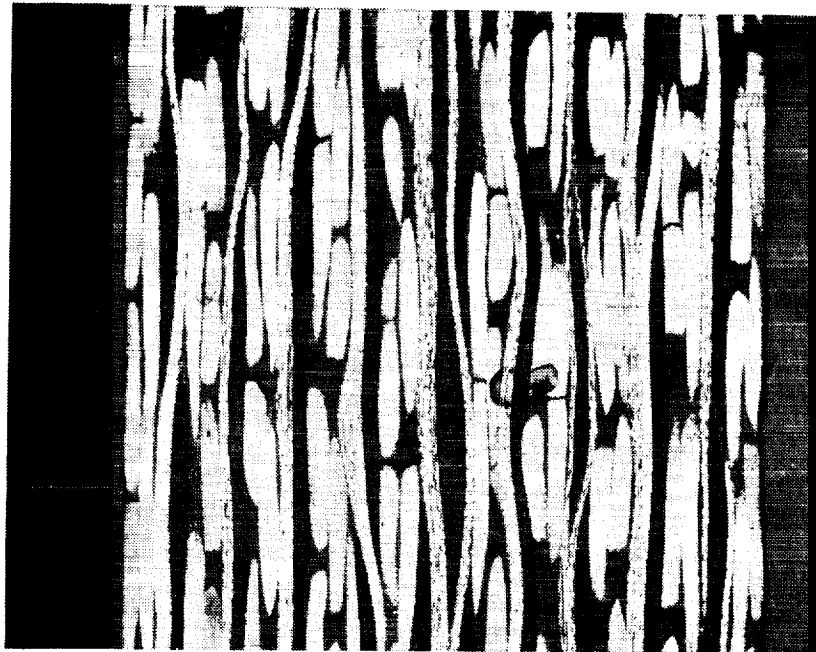
Figure 9. Photomicrograph of a "good" area of the plank

The 17-ft plate was postcured at 400°F for 4 hours then C-scanned. Numerous indications of delaminations and porosity were found, however, the first 5 feet appeared to be free of voids. Photomicrographs of both "good" and "bad" areas indicate problems throughout the laminate. Figure 9 shows a section of a "good" area while Figure 10 is from a "bad" area. Microcracking is apparent in both photos. Severe fabric distortion is seen on Figure 10.

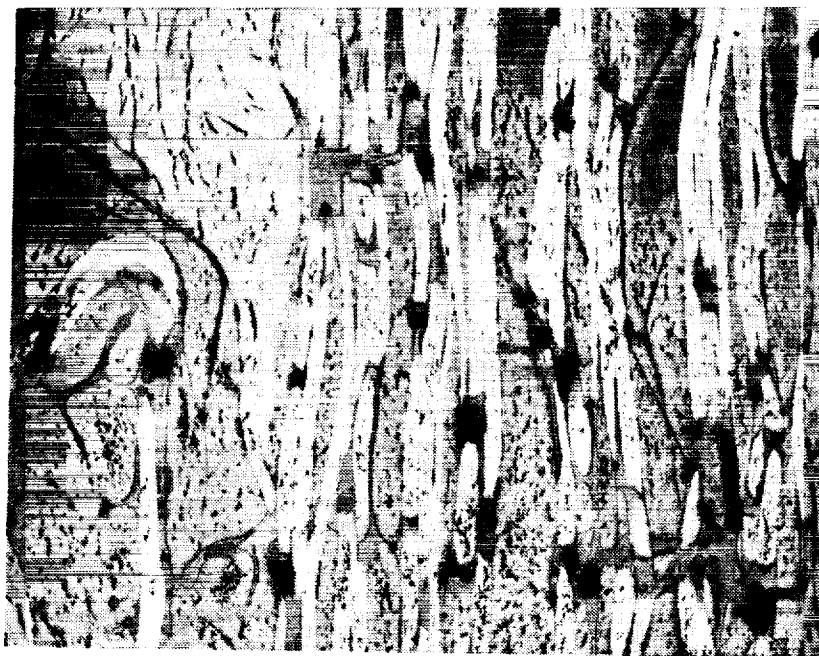
Figures 21 and 22 show typical porosity found in the panel. Most of the voids occur between tows but these are indications of porosity in some of the tows. Resin content measurements were made in the skin and blade areas. The skin areas had resin contents of 36 to 39 percent while the blades were between 30 and 32 percent. This result suggests that additional plies should be included in the skin.

Figure 21. - Photomicrograph through skin area directly under a stiffener

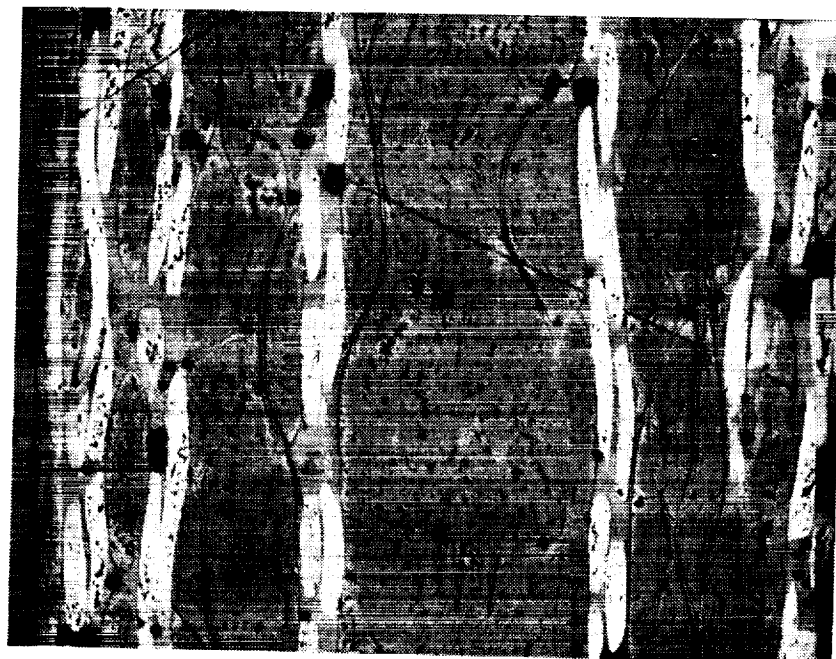
Figure 22. - Photomicrograph through a stiffener

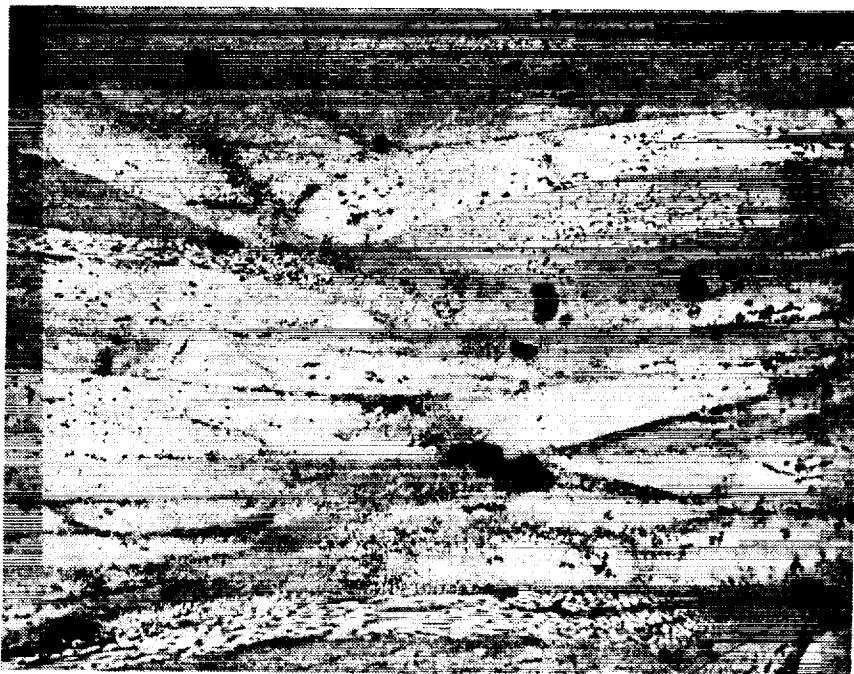
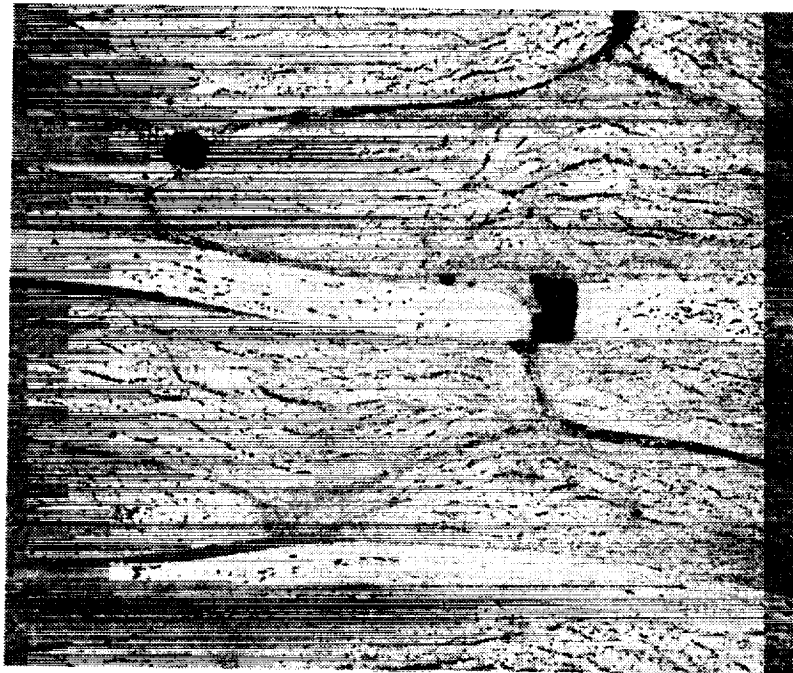
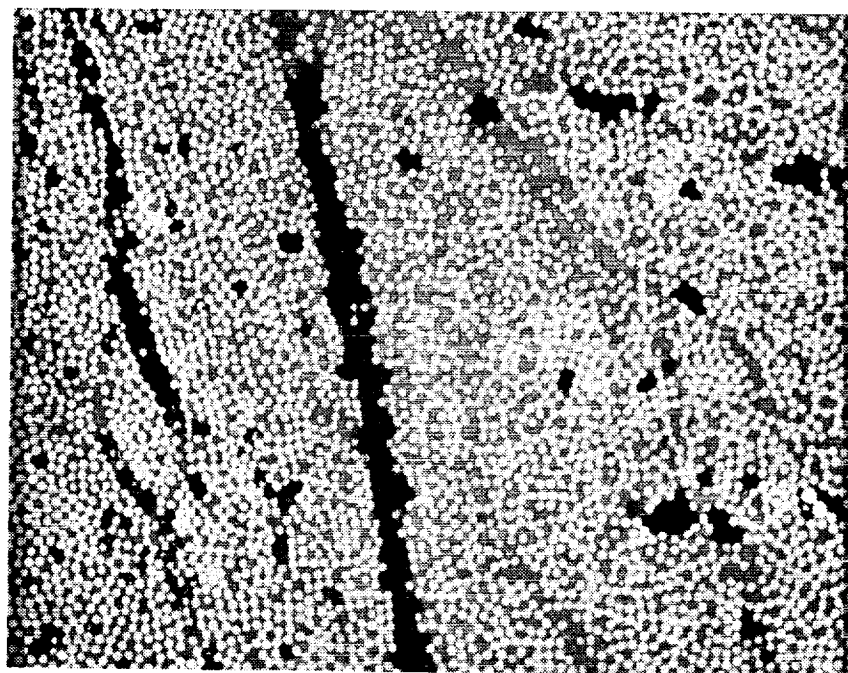
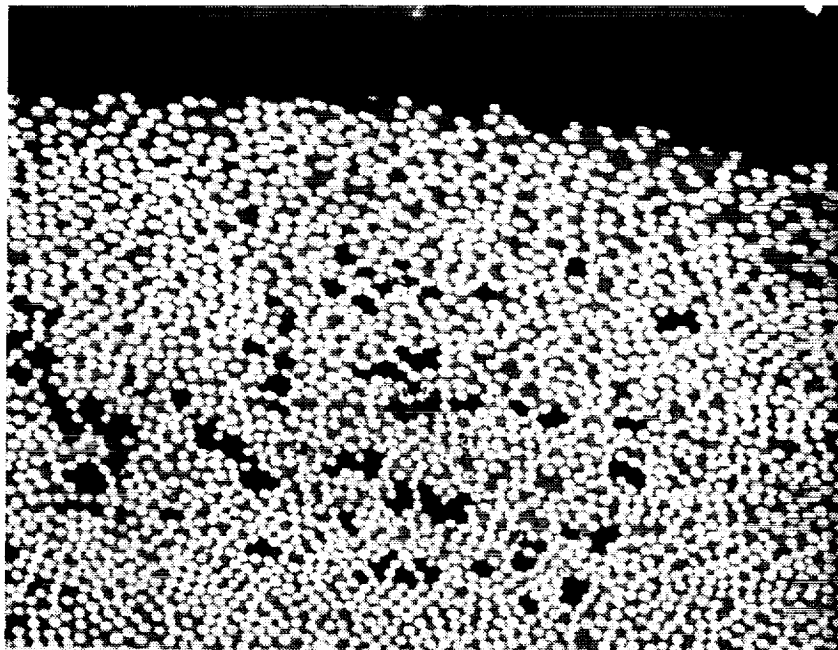
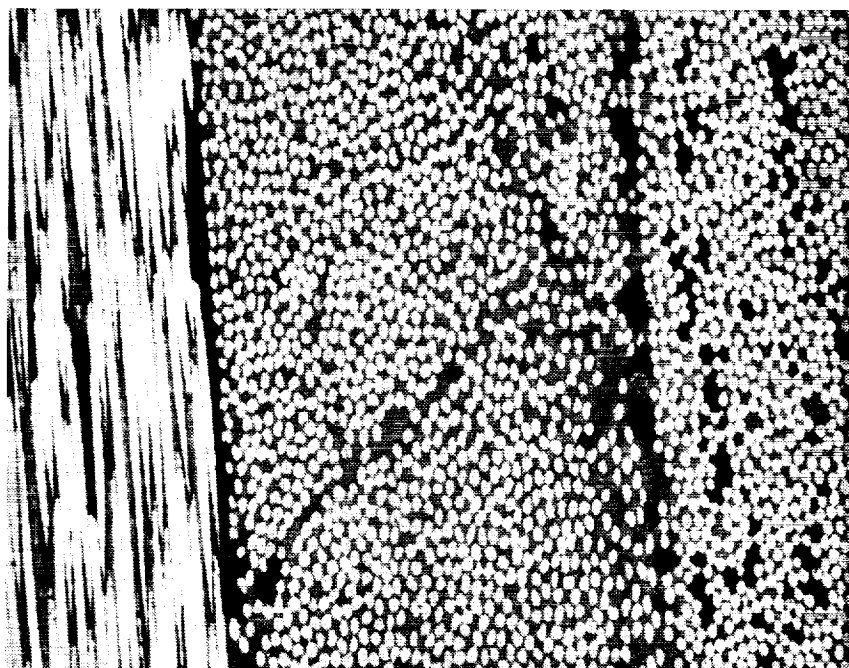
Figure 27. Key to photomicrograph locations

Preliminary measurements showed the first 1986 panel to have 1.5 percent voids in the skin section compared to 0.75 percent voids in the 1987 panel. Measurements at the base of the stringer indicated 2.0 percent in the 1986 panel and 1.9 percent in the 1987 panel. However, the resolution of the camera may exclude a significant void area. A higher resolution system was sought to better measure the void content.

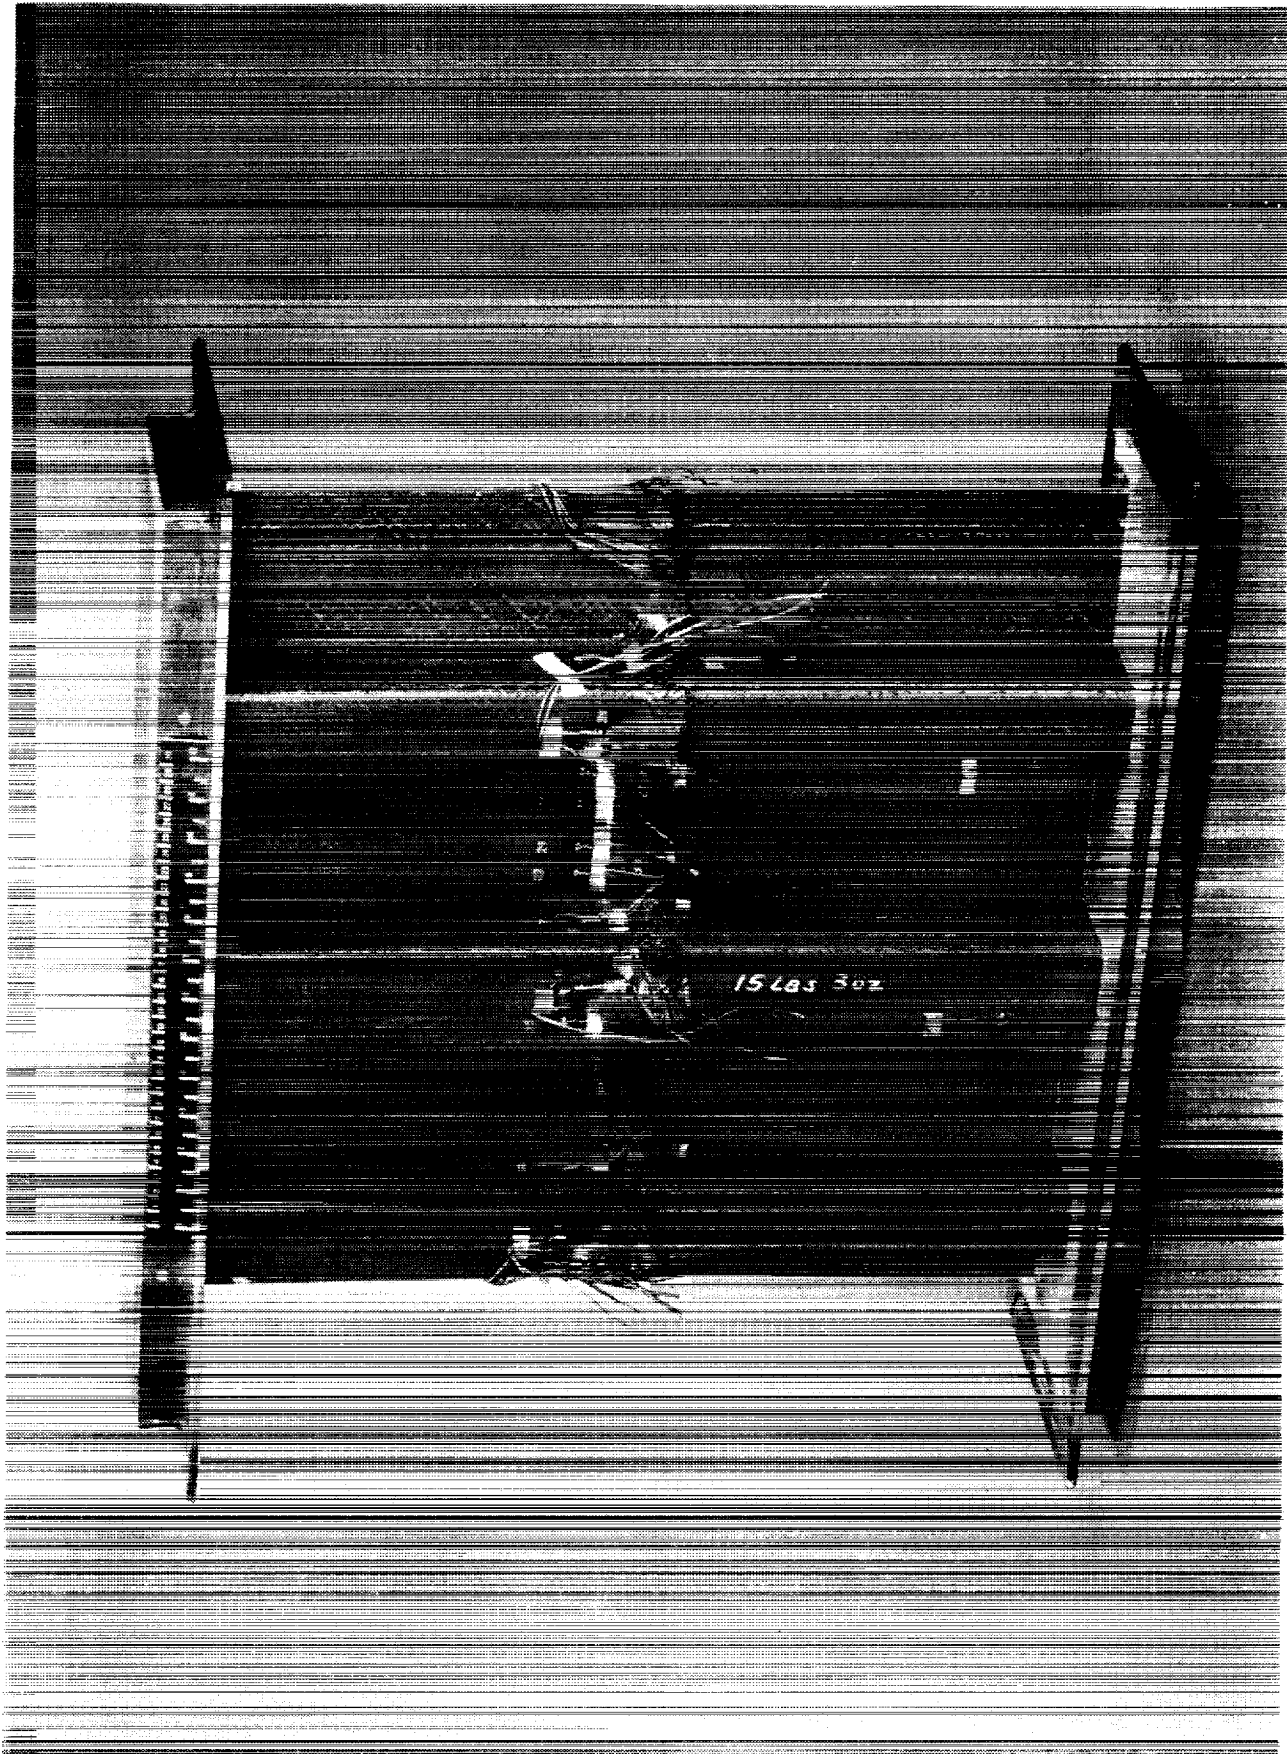
Figure 30. - Typical compression specimen after failure

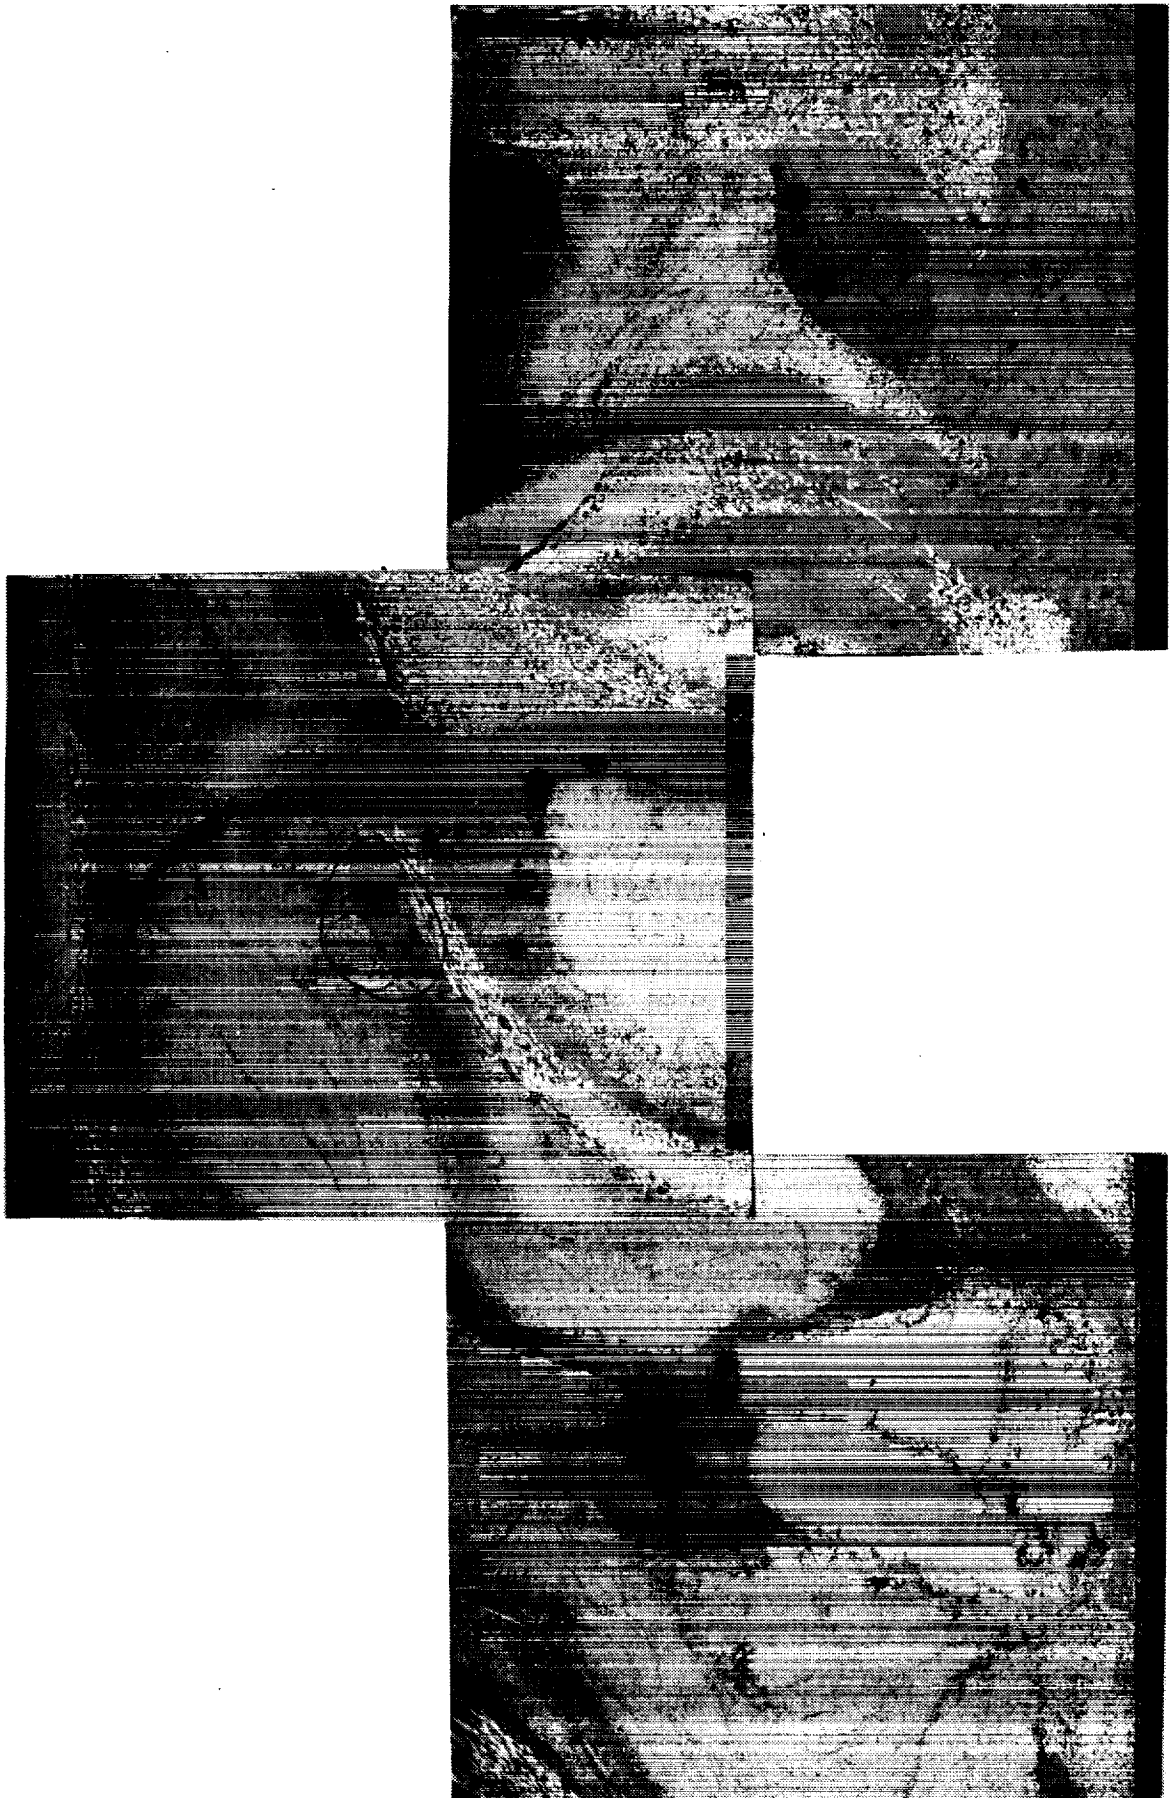
Figure 49. - Photomicrographs showing void locations near polyester stitching yarns and clay filler particles

After analyzing the photomicrographs of the second pultrusion trials, it was noted that a lot of the residual porosity was "attached" to the polyester stitching yarns and the clay filler particles as described by the photomicrographs in Figure 55.

The voids near the Dacron stitching yarn and the clay filler particles could have several causes. Both the Dacron and the clay (Kaoline) are hydrophillic. They could have absorbed small amounts of water which would evaporate during the pultrusion process. Pre-drying both the clay and the pultrusion fabric would eliminate this problem. In addition, the Dacron or a sizing used with the Dacron could be degrading just enough to cause the porosity seen in Figure 53. A solution to this problem would be to use carbon stitching thread. When this program was initiated, the vendor (Hi-Tech/Hexel) was questioned about using a carbon stitching yarn. At that time, the a carbon yarn was a developmental product and could not be delivered during this program. Today, however, the carbon stitching yarns could replace the Dacron.
